Foundering of the fishing vessel

Diamond

resulting in the death of a crew member West Burra Firth, Shetland, United Kingdom

25 March 2014

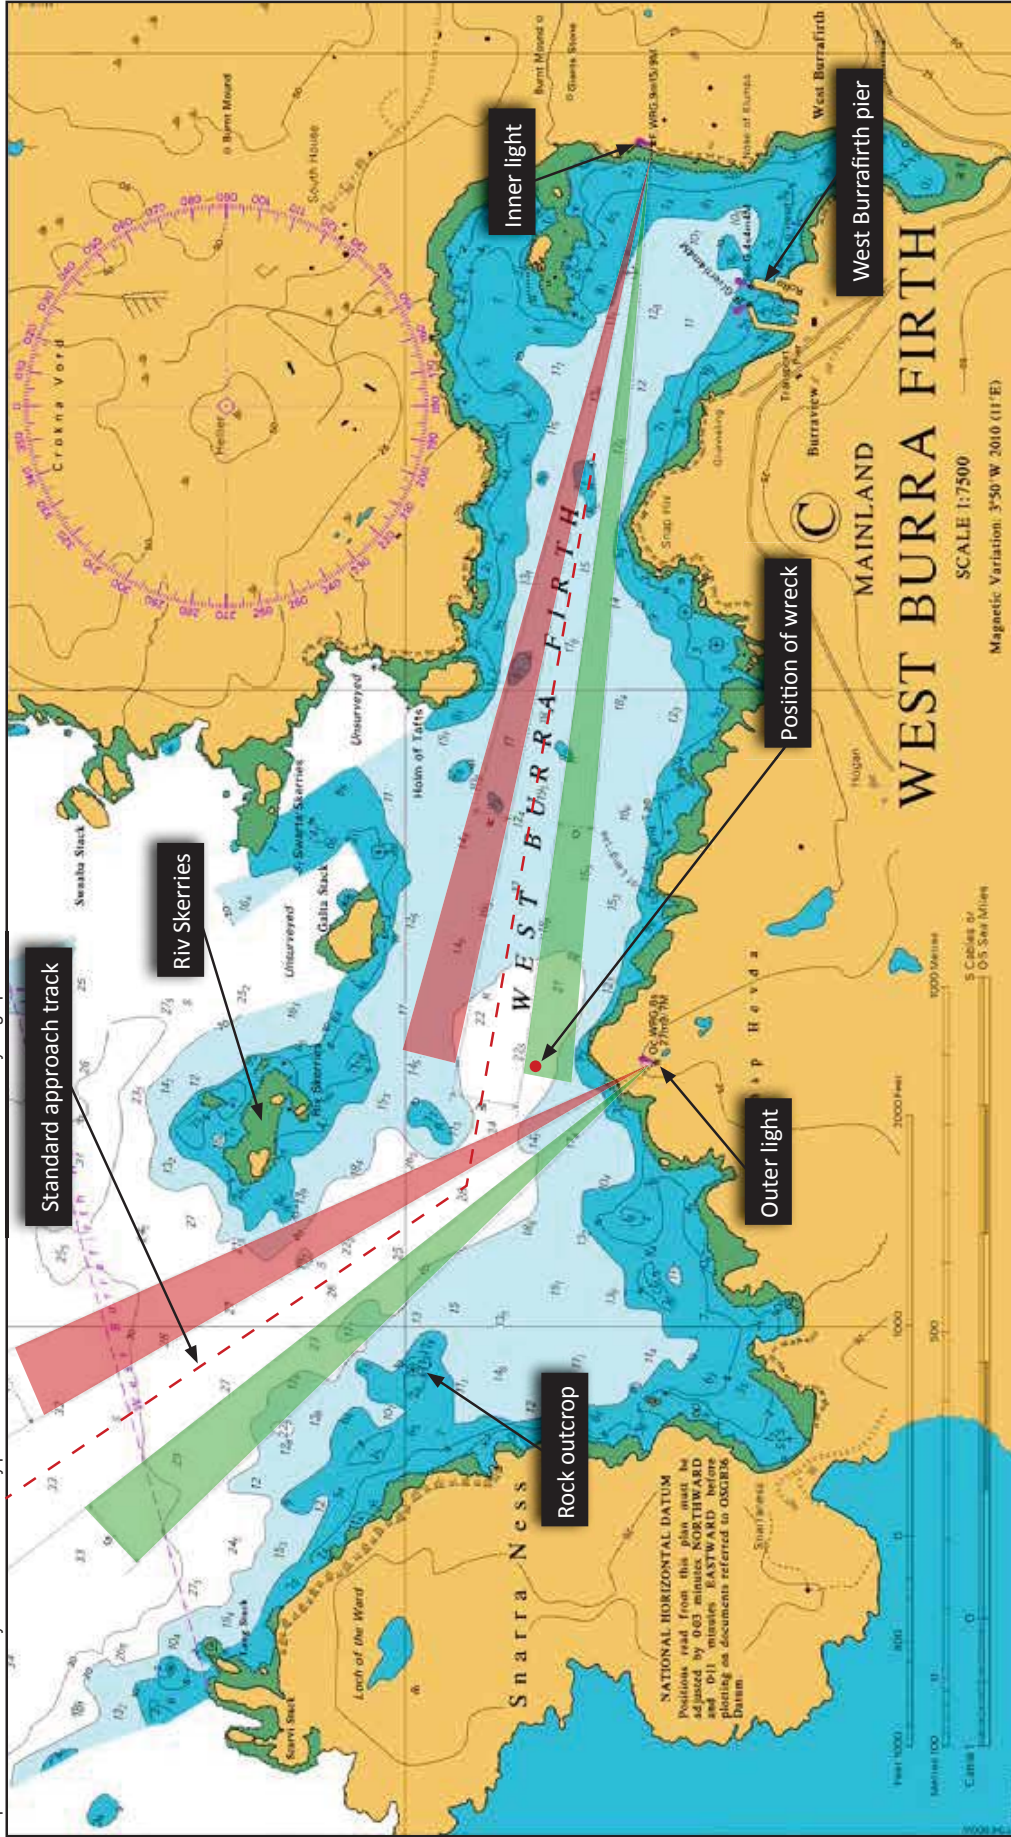
Figure 3: Chartlet of West Burra Firth with added sector light colours and standard approach track. The red dot shows the position of *Diamond* on the seabed

The evidence indicates it is most likely that *Diamond* hit the rocky outcrop east of Snarra Ness. The skipper navigated into the firth from the north-west and *Diamond* was observed, by another fishing vessel, to be closer to the coast of Snarra Ness than would be expected, and probably to the west of the outer light safe sector.

Diamond struck a rock outside of the main navigation channel, most likely to the east of Snarra Ness.

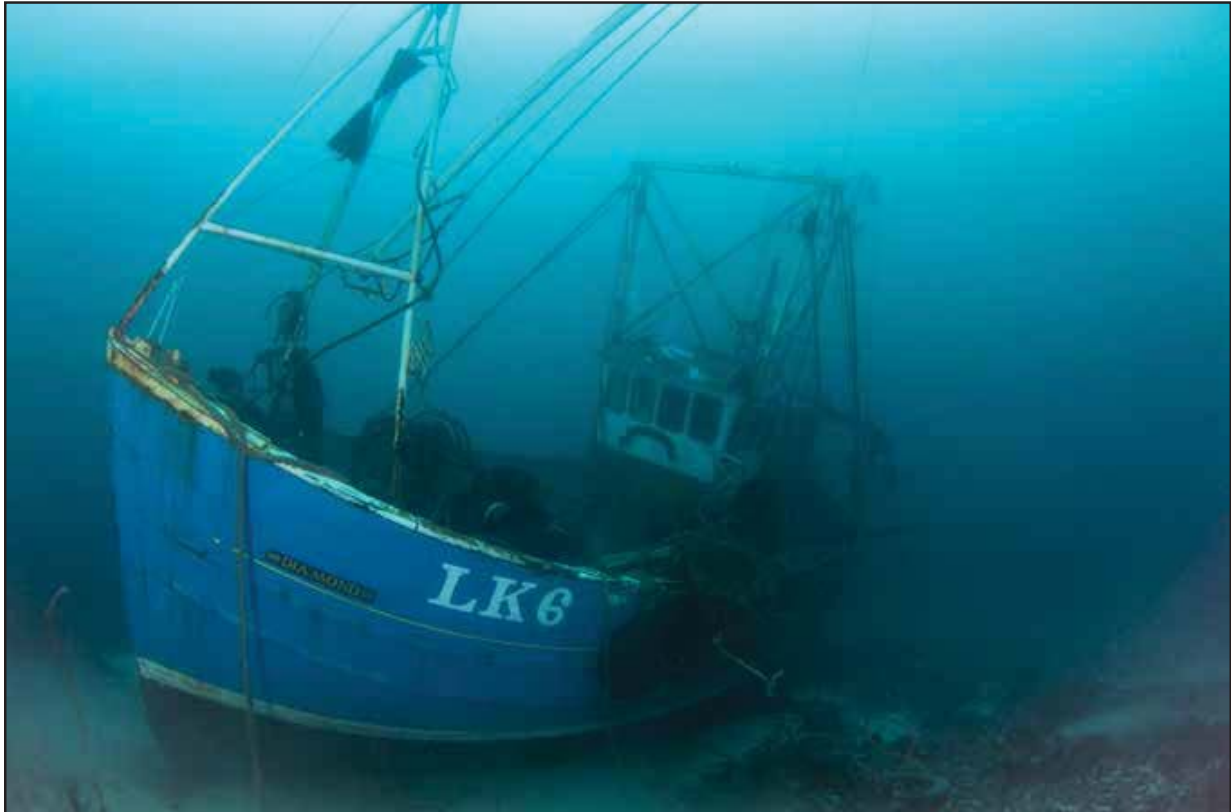
The rudder was found to be at about 15° to port and the engine controls in the ahead position at about 75% of full travel. Other details noted were: the scallop dredge gear was displaced forward; the main hold hatch cover was off; and the lifebuoys were wedged tight in their holding brackets.

Figure 4: *Diamond* resting on the seabed

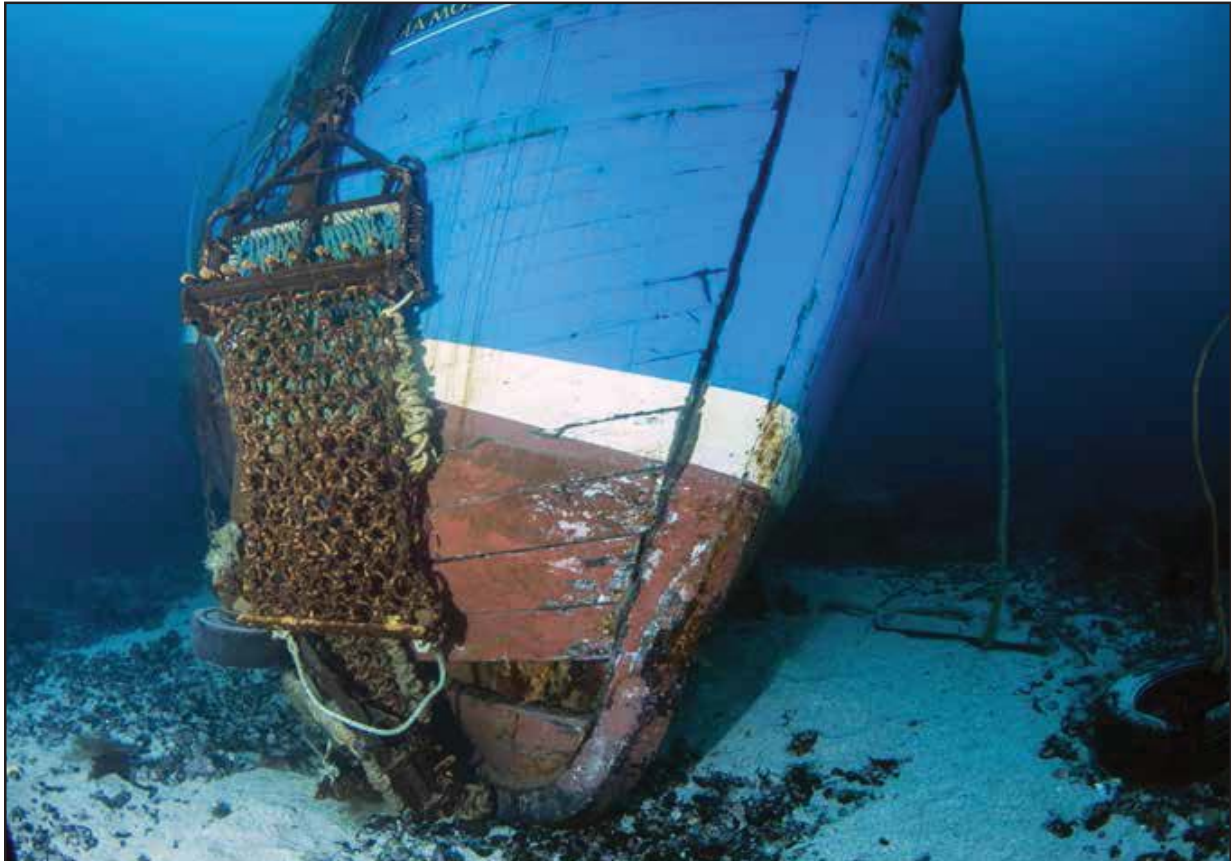
On 29 April 2014, a commercial diving team contracted by the MAIB conducted a visual survey of the vessel's exterior. The wreck was located in position 60°17'.9N 001°33'.62W (**Figure 4**). The inspection showed damage to the bow, specifically stem damage with substantial scraping on the port side. The hull planks were displaced and a section of plank was missing on the starboard side (**Figure 5**).

Figure 5: Photograph of stem and starboard side of *Diamond* showing missing and displaced planks

Diamond was travelling at between 5 and 6 knots. The force of the grounding taken on the stem displaced several planks on both sides, particularly the starboard side. The damage to the hull allowed water to flood the hull which had no watertight integrity between spaces.
